PHASE I REPORT
NATIONAL DAM INSPECTION PROGRAM

Name of Dam: SCS DAM PA-419
State & State No.: PENNSYLVANIA, 64-170
County: WAYNE
Stream: TRIBUTARY TO INDIAN ORCHARD BROOK
Date of Inspection: November 7, 1979

SCS DAM PA-419

NDI-ID NO. PA-00086
DER-ID NO. 64-170

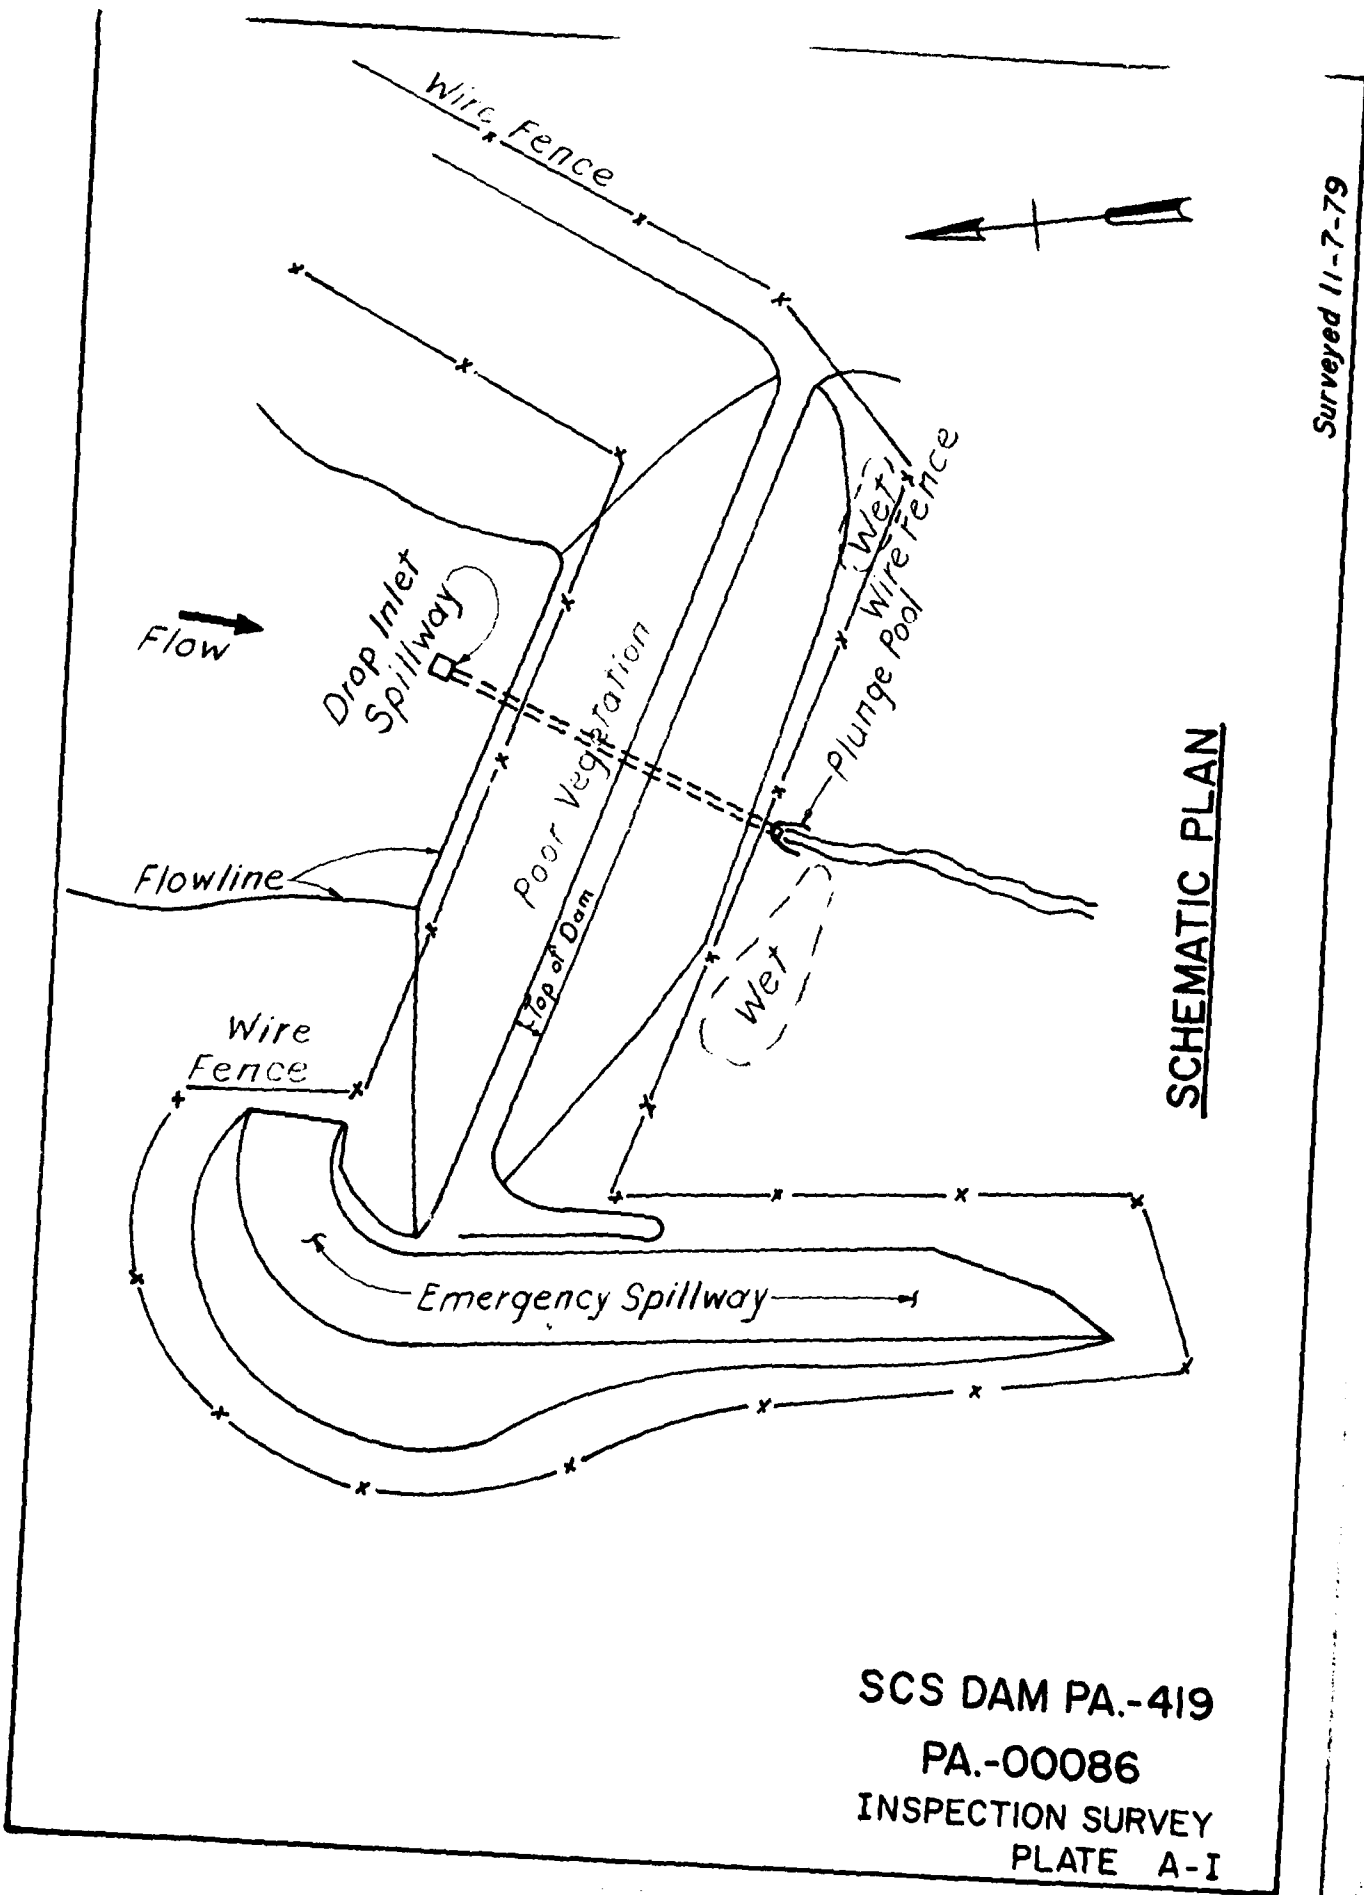
One wet area was observed downstream from the downstream toe of the embankment on the right side. The area is above pool level; hence, this drainage is attributed to the side hill drainage rather than seepage through the embankment.

F. JUNCTION EMBANKMENT & ABUTMENT OR SPILLWAY	Embankment abuts natural ground on left side-good. Right side ends at emergency spillway - no abutment.
G. SEEPAGE	None observed through or under the embankment. Side hill drainage was noted. See sketch (Plate A-I).

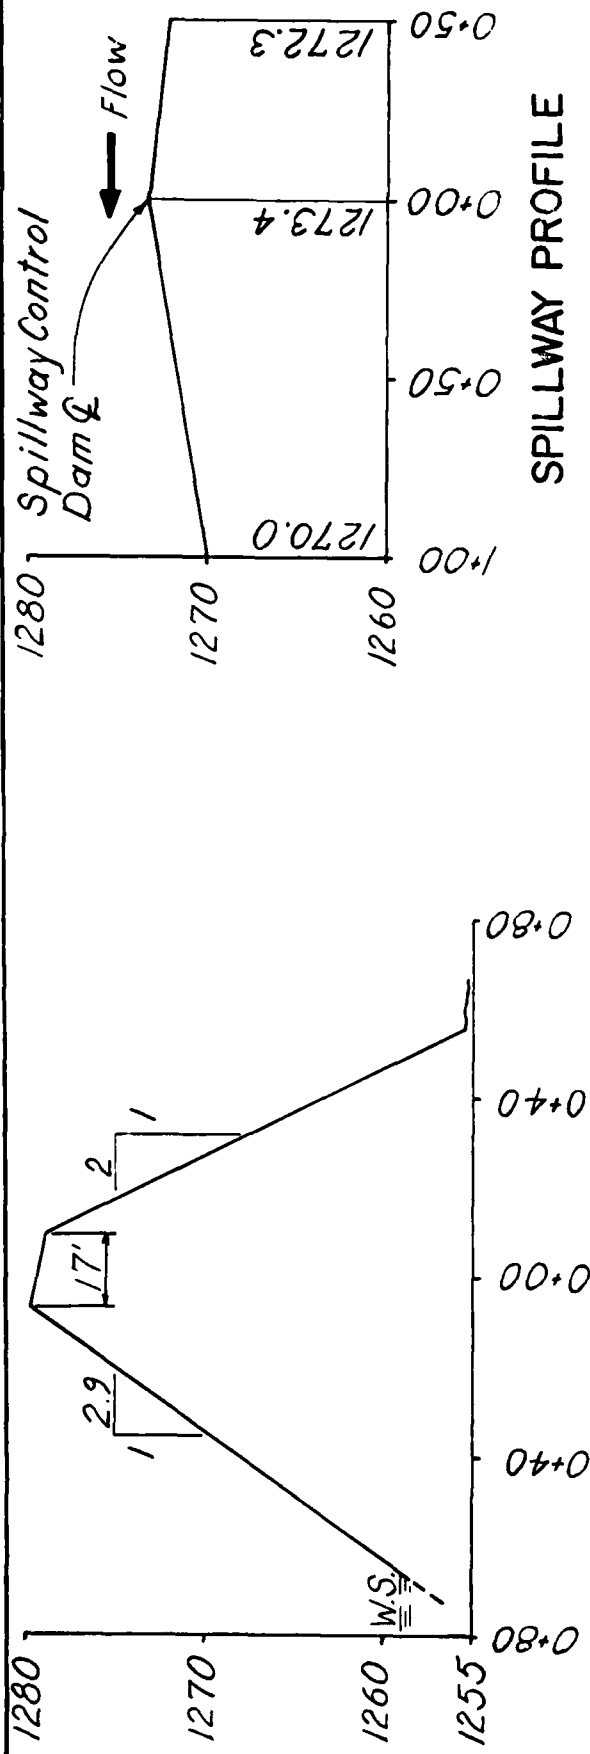
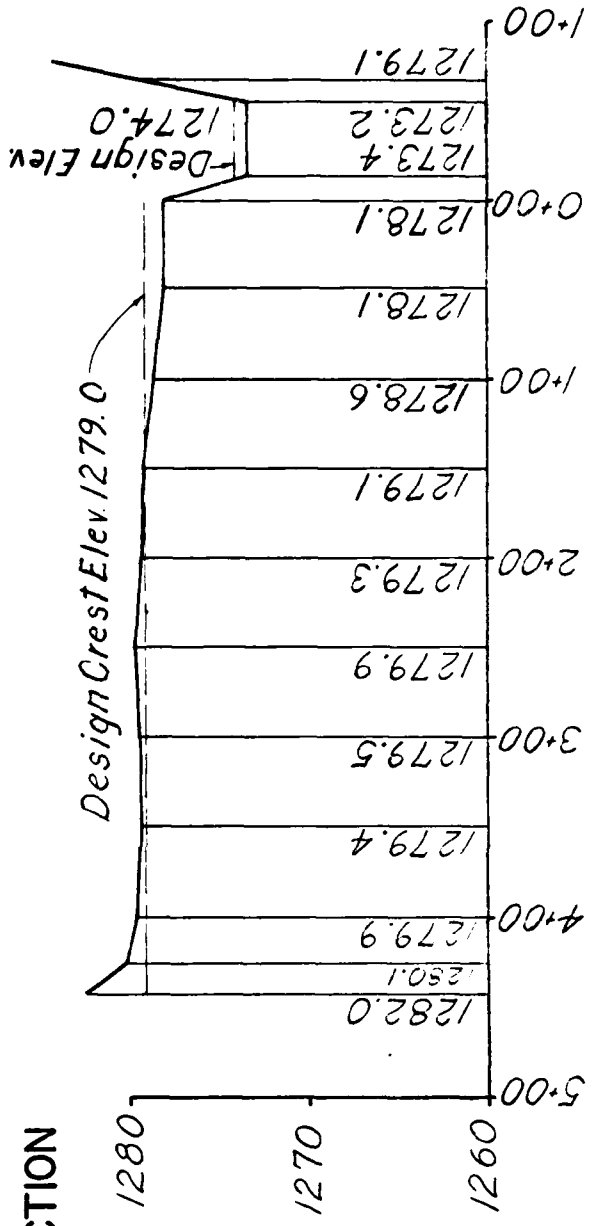
SCS DAM PA.-419
 PA.-00086
 INSPECTION SURVEY
 PLATE A-II

D. ALIGNMENT OF CREST: HORIZONTAL: VERTICAL:	Horizontal alignment is good. See Survey profile for vertical alignment (Plate A-II).
E. RIPRAP FAILURES	Riprap is about 6 feet above normal pool elevation. Good condition.

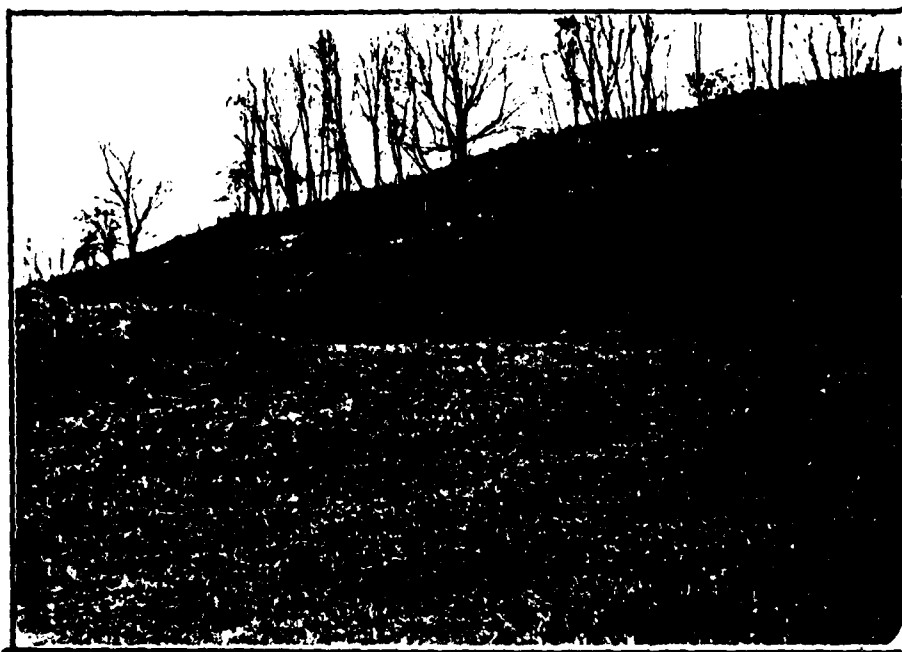
The emergency spillway in the right abutment appeared to be in good condition with a good grassmat for erosion protection. The side slopes are stable and the flow of water is directed away from the toe of dam by a spur dike (Appendix A, Plate A-I).

EMERGENCY SPILLWAY LOOKING DOWNSTREAM - NO. 6

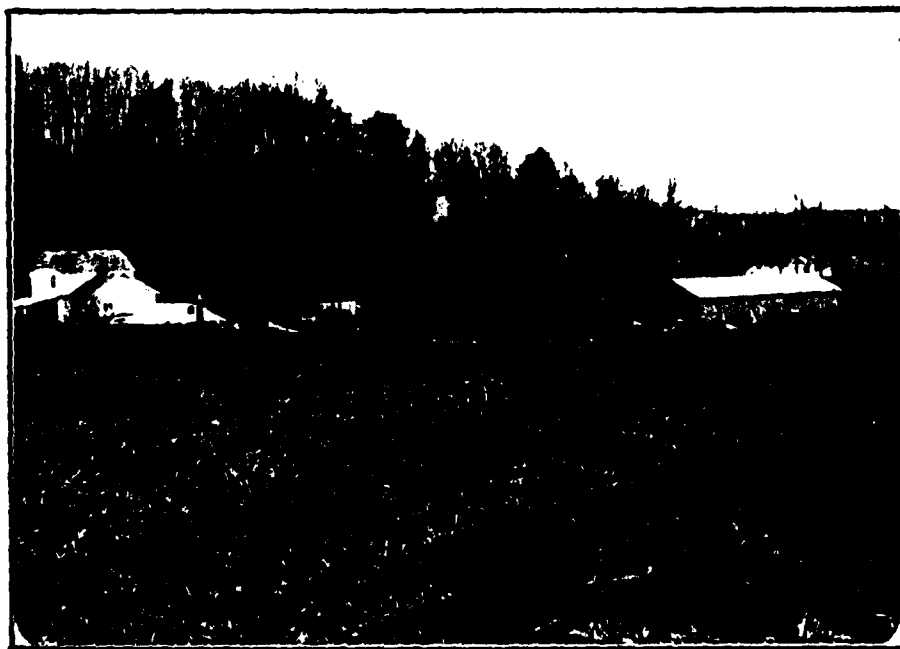
END OF EMERGENCY SPILLWAY - NO. 7
NOTE: FENCE ACROSS SPILLWAY
